Harbour Club Condominium No. Three, Inc.

October 31, 2023 • Belleair Bluffs, FL

**STRUCTURAL INTEGRITY
RESERVE STUDY**

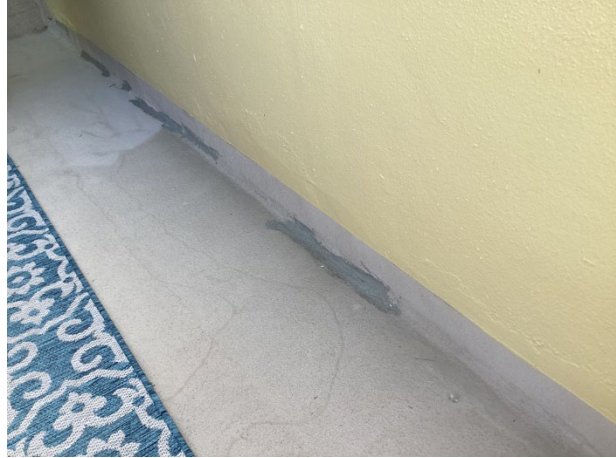
Condition: Good to fair overall with minor previous repairs and coating deterioration evident. We note the following:

- Sealants are in good to fair condition
- The coatings are in good to fair condition
- Isolated concrete coating deterioration is evident
- Exposed reinforcements were not observed at the time of our inspection

Previous repairs and coating deterioration

Useful Life: Capital repairs including a close-up visual inspection, patching of delaminated concrete, routing and filling of cracked concrete, and waterproof coating applications every 8- to 12-years.

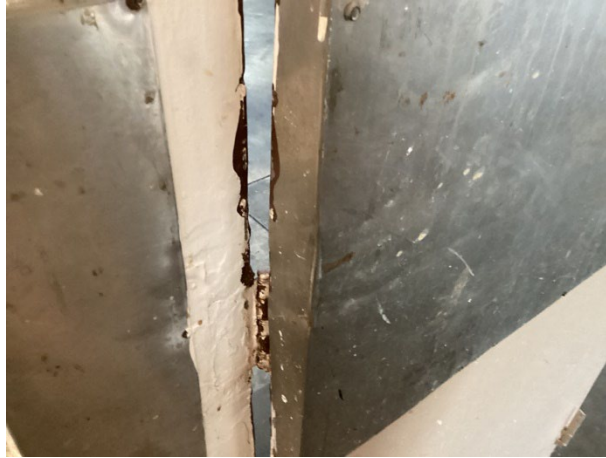
Condition: Good to fair overall with isolated rust evident.

Rust at the common area door

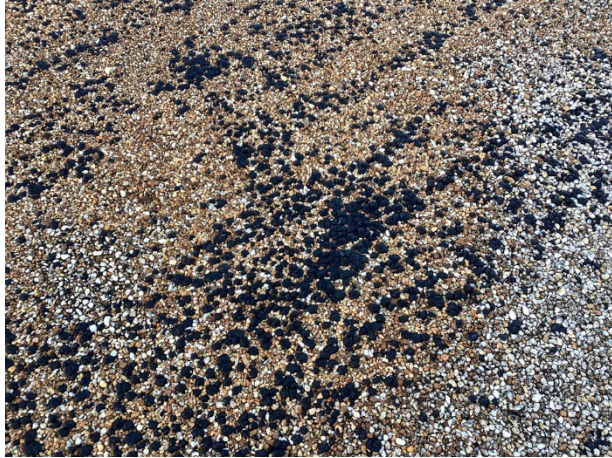
Condition: Fair to poor overall with extensive ballast encapsulation, ballast displacement and ridging evident. Management and the Board do not report history of leaks.

Ballast encapsulation at the upper roof

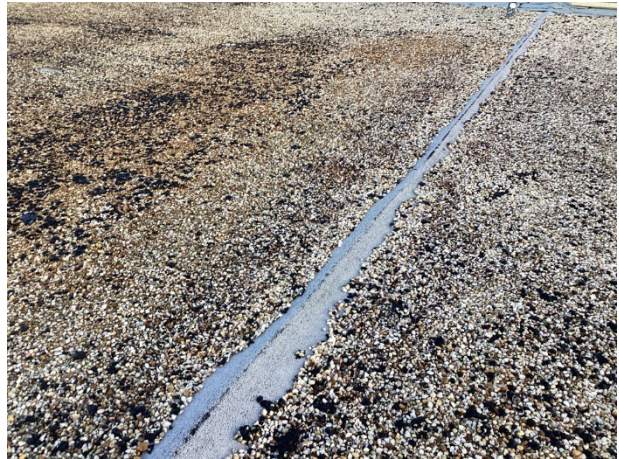
Ridging at the upper roof

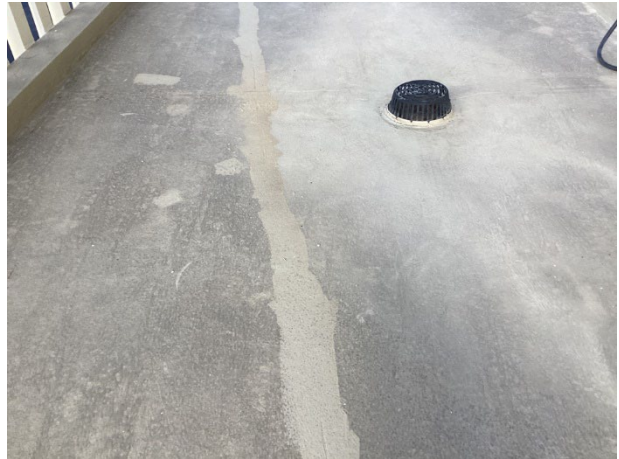
Condition: Good to fair overall with isolated previous repairs evident. Management and the Board do not report history of leaks. We note the following:

Previous repairs at the lower roof

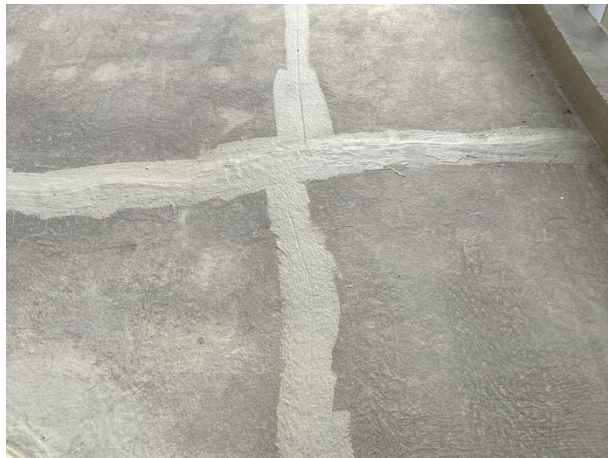
Previous repairs at the lower roof

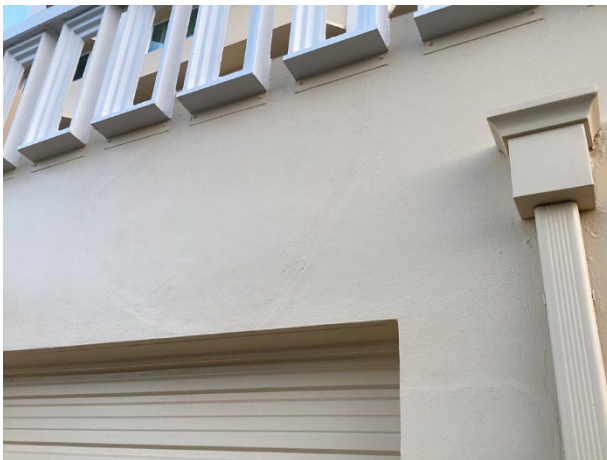
Condition: Good to fair overall with isolated cracks, previous repairs and spalls evident. We note the following:

Previous repairs

Useful Life: We recommend inspections, repairs and paint finish applications every five- to seven-years.

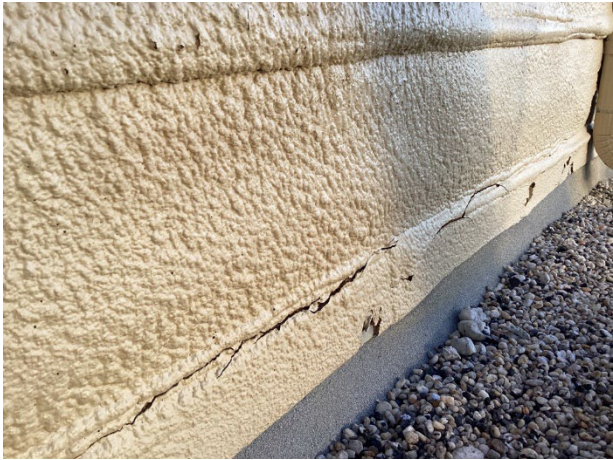
- Isolated cracks are evident
- Isolated spalls are evident
- Sealants are in good condition

Stucco cracks

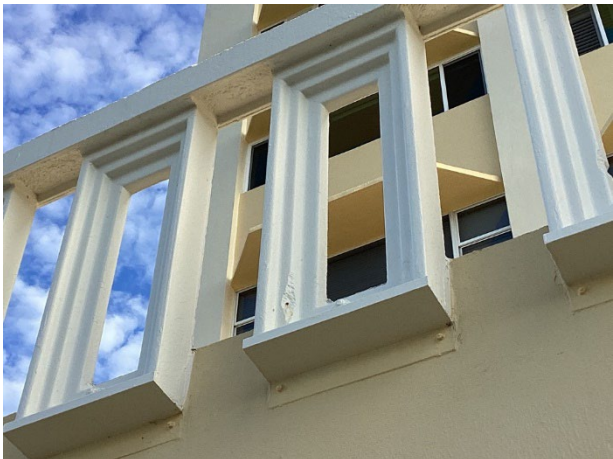
Concrete balcony railing with spalls

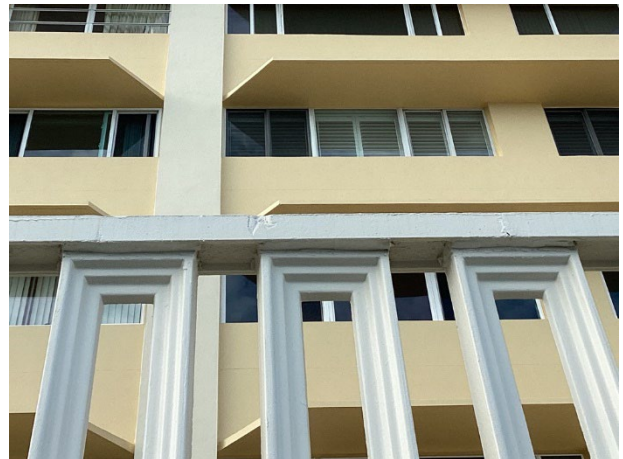
Concrete balcony railing with spalls

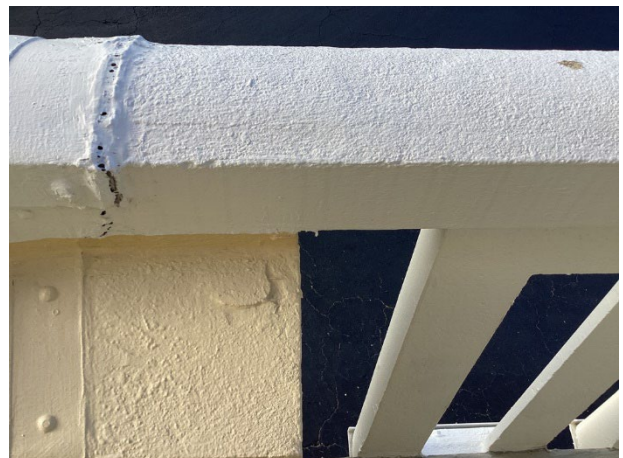
Concrete balcony railing with crack

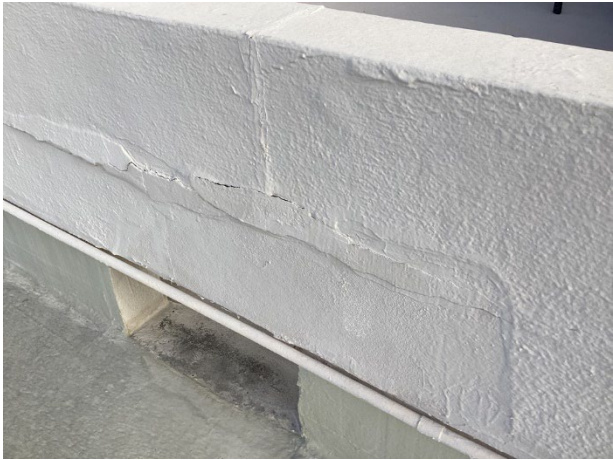
Stucco cracks

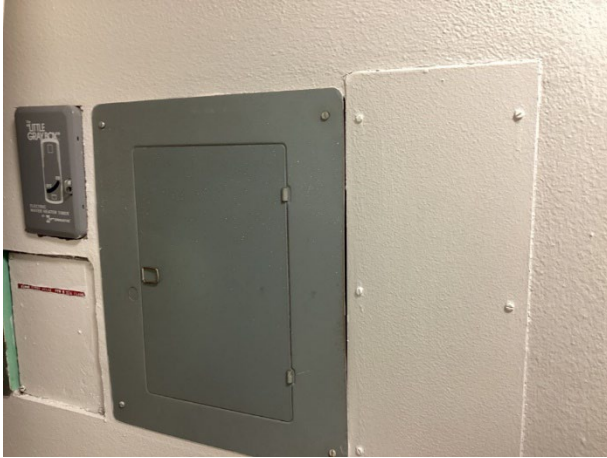
- We observed potentially combustible materials stored near the electrical panels. Per 10.18.5 of NFPA 1, "Combustible material shall not be stored in boiler rooms, mechanical rooms, or electrical equipment rooms.". The Association should further investigate and remove materials, if necessary.
- Some electrical panel locations were not labeled. The Association should consider adding clear and proper signage to the electrical panel locations.
- No obvious exposed wires were observed during our site inspection. However, our inspection is not exhaustive and the Association should conduct periodic inspections of the electrical rooms to ensure no unsafe conditions develop.
- Rust was not present at electrical panels. Continual monitoring of the panels is prudent to ensure excessive moisture is not present at them.
- No apparent water was observed in or near the electrical rooms.

Electrical system components

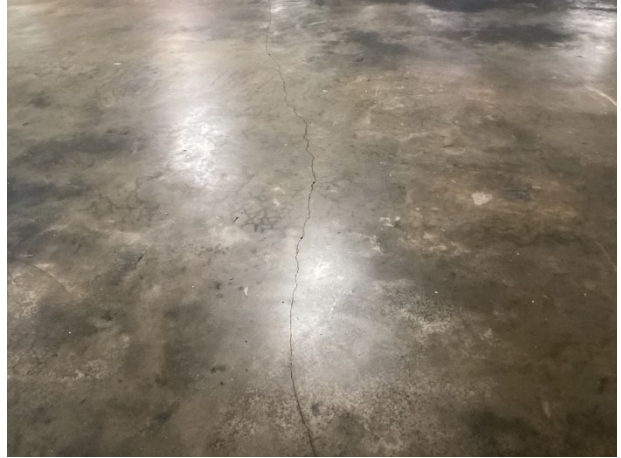
Condition: Fair overall with cracks evident. We note the following:

Concrete cracks

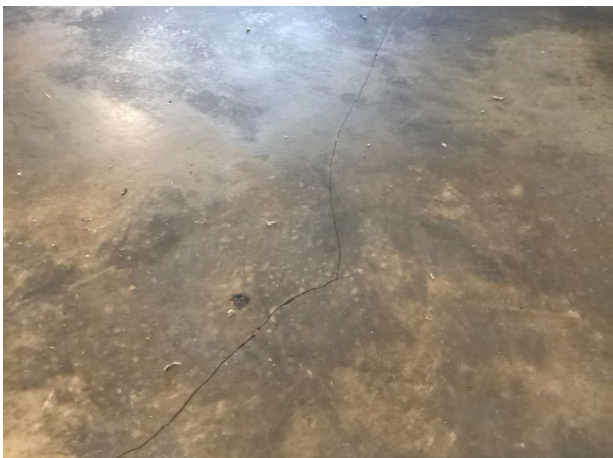
Concrete cracks

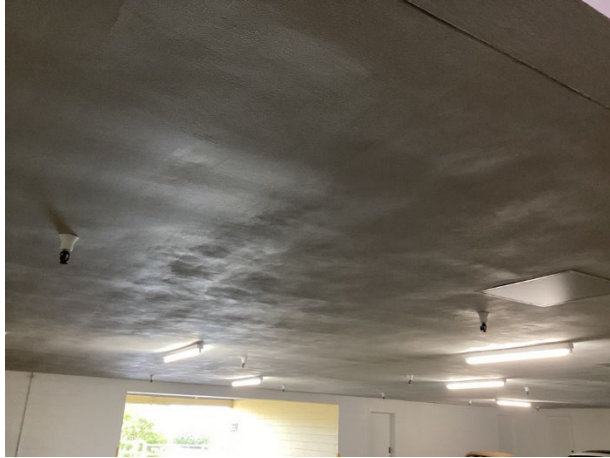
- Management and the Board report isolated areas of pipe replacements
- We note frequent locations of sprinkler head replacements
- No significant hanger rust was observed

Fire suppression system
