MILESTONE PHASE 1 CONDITION SURVEY REPORT

Harbour Club Condominium No. Three

100 Bluff View Dr., Belleair Bluffs, FL 33770

**Subject: Milestone Phase 1 Structural Condition Survey Report
Harbour Club Condominium No. Three
100 Bluff View Dr.
Belleair Bluffs, FL 33770**

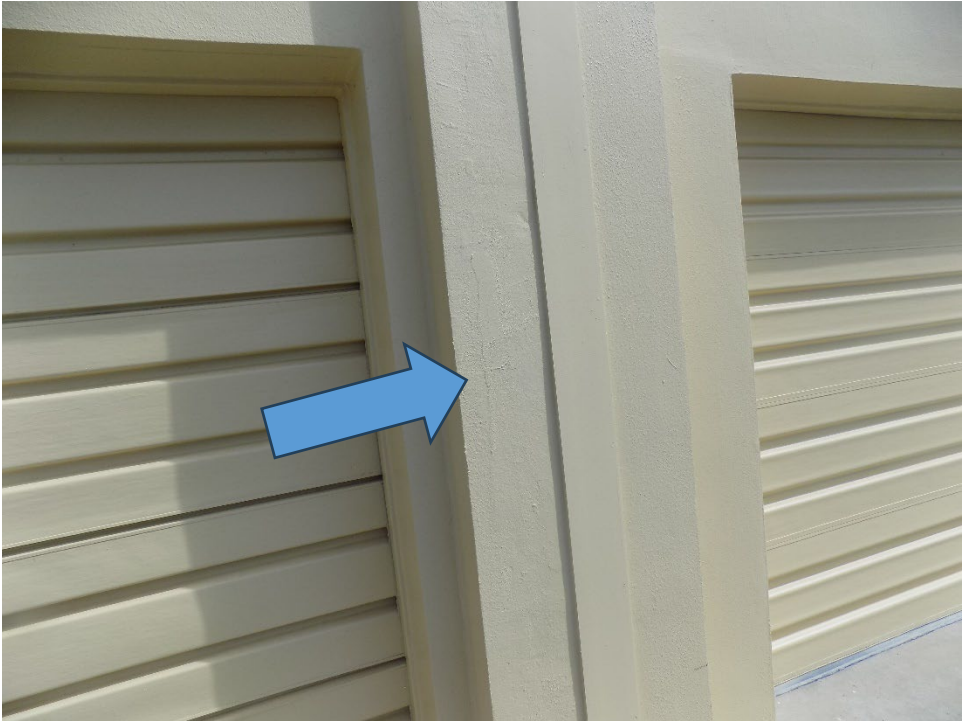
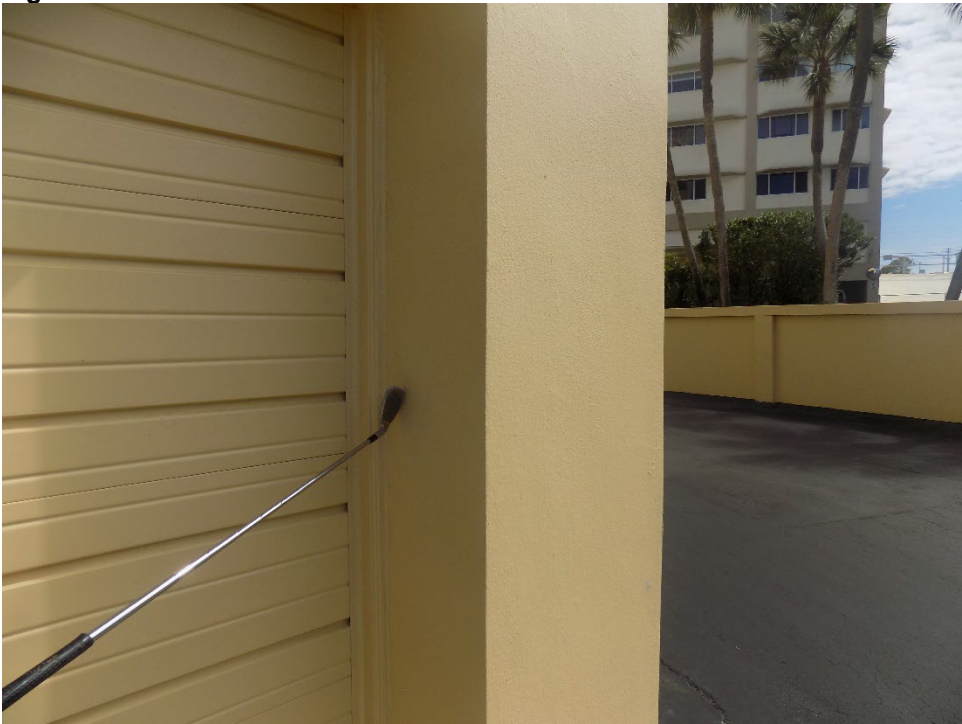
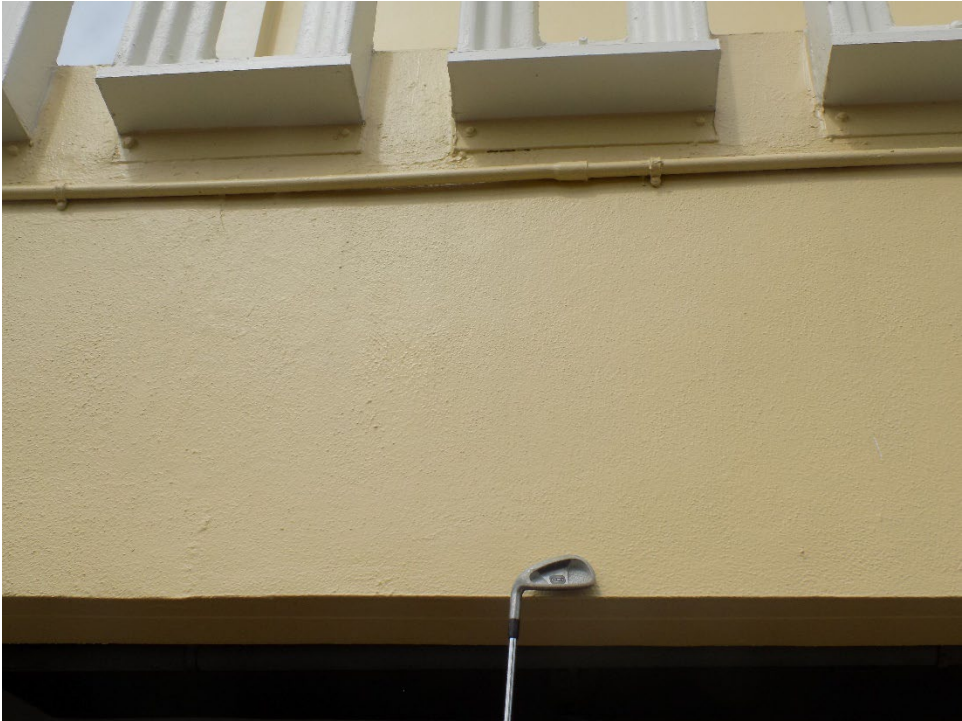
1. South elevation, North elevation, West elevation, and East elevation exterior wall areas are shown in *Figure A-1* through *Figure A-4*, respectively.
2. Multiple areas of stucco delamination were detected throughout the accessible ground level exterior walls. Refer to *Figure A-5* through *Figure A-7*.
3. Isolated areas of blistering paint with entrapped moisture were detected on the exterior walls. Refer to *Figure A-8*.
4. Isolated areas of corrosion staining were detected on the precast rail surfaces. Refer to *Figure A-9*.

Based on the detection of multiple areas of stucco delamination and cracks within the exterior walls and balconies, BillerReinhart recommends a restoration project be undertaken for the repair and maintenance of all the exterior wall surfaces including deteriorated concrete structural elements, stucco, sealants, and touch up painting. Restoration of the exterior wall areas should mitigate potential moisture intrusion and expose any structural deterioration of underlying structural elements in need of repair. BillerReinhart recommends the exterior wall restoration and waterproofing project be undertaken within the next 4-5 years.

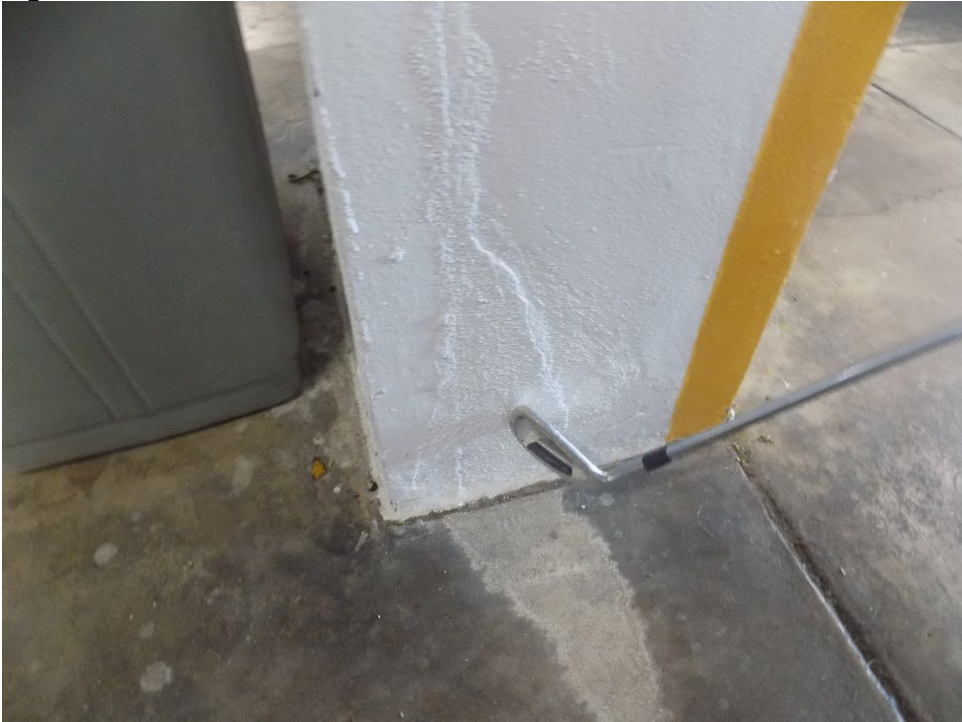
Figure A-12

1. An overall view of a typical parking garage area can be seen in *Figure A-10* and *Figure A-11*.
2. Localized areas of concrete spalling and/or delamination were detected on the parking garage columns. Refer to *Figure A-12* through *Figure A-14*.
3. Isolated areas of concrete spalling with exposed corroded reinforcement were observed on one of the parking garage overhead beams. Refer to *Figure A-15*.

The Parking Garage structures generally appear to be in good condition, with sporadic areas of delamination and spalling. BillerReinhart recommends a restoration project be undertaken for the repair and maintenance of the parking garage area. The project would include cleaning and re-coating the exposed open web steel joist members. BillerReinhart recommends the restoration project be undertaken during the same time as the exterior wall project described above.

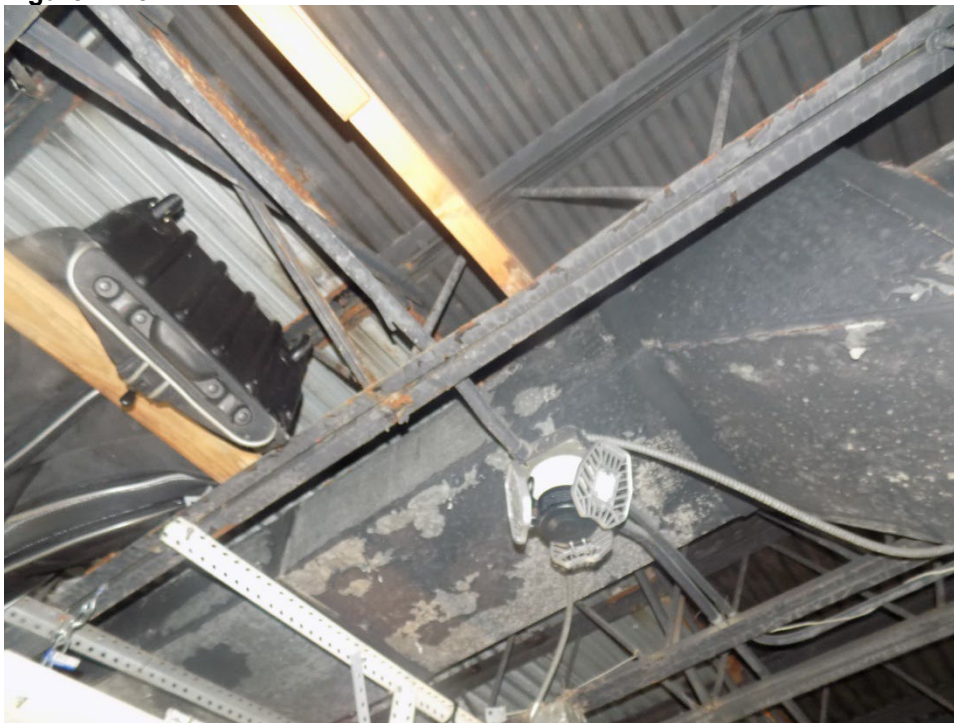
Figure A-16

4. Sporadic areas of coating deterioration and surface corrosion were observed on the open webbed steel joists in the unit garages. Refer to *Figure A-16* through *Figure A-20*.
5. A hairline wall crack was observed at the CMU wall of unit garage 67. Refer to *Figure A-21*.
6. A localized area of concrete spalling with exposed reinforcement was observed in unit garage 67. Refer to *Figure A-22*.

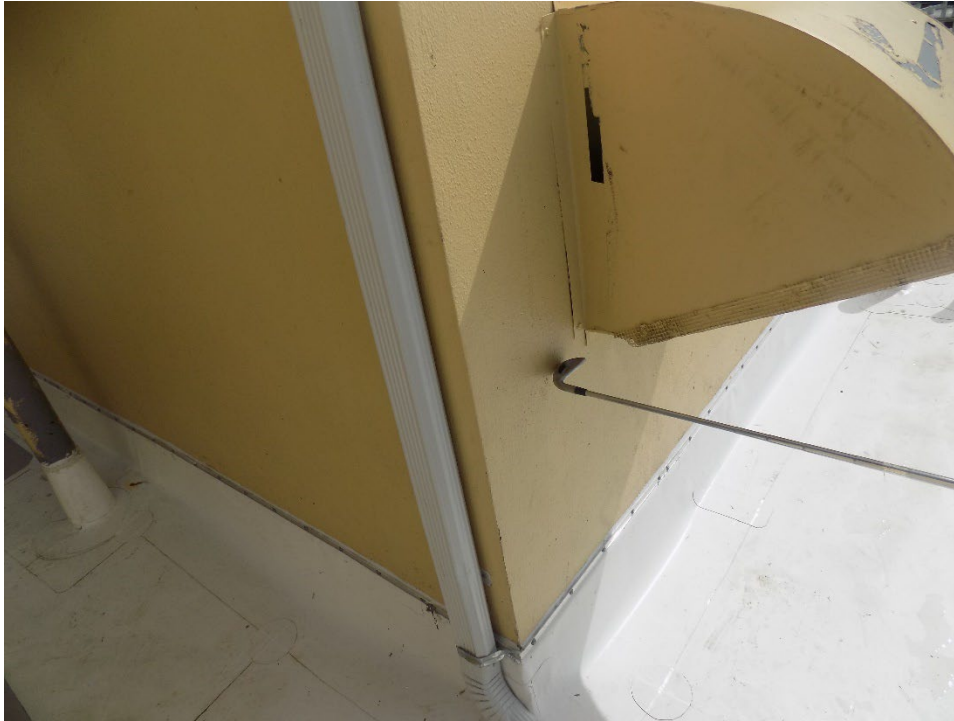
Figure A-25

1. The roof was generally observed to be in good condition. An overall view of the roof can be seen in *Figure A-23* through *Figure A-24*.
2. Localized areas of delaminated stucco and spalling were detected on the walls of the rooftop structures. Refer to *Figure A-25* through *Figure A-26*.
3. Multiple areas of ponding with staining were observed throughout the main roof area. Refer to *Figure A-27*.
4. The west elevator stair landing was observed to exhibit signs of corrosion with section loss at the wall to landing angle support connection and top tread plate. Refer to *Figure A-28* and *Figure A-29*.

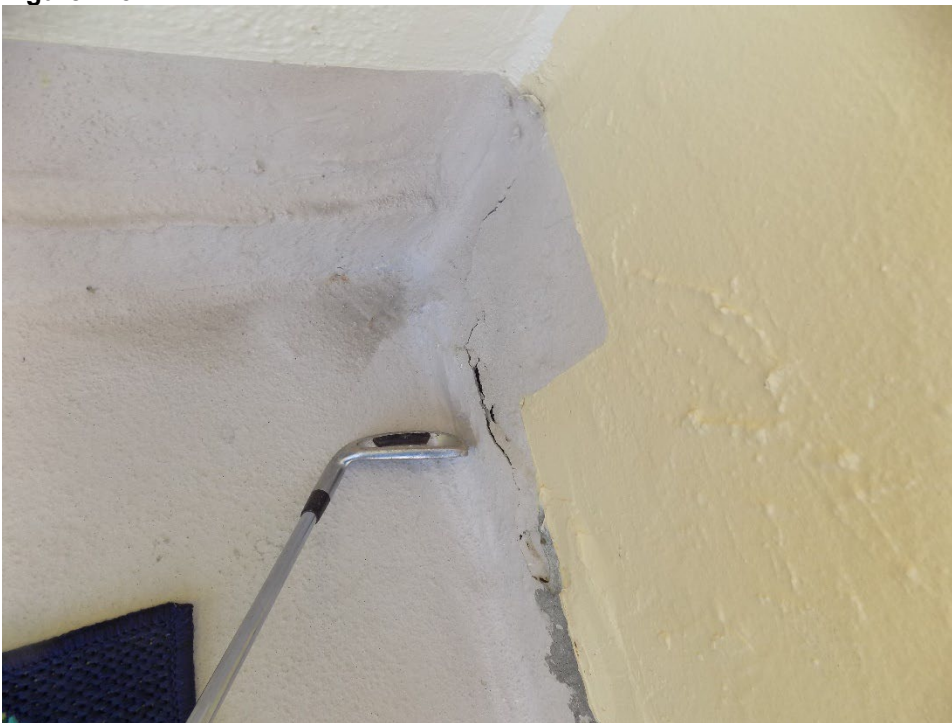
Figure B-6

1. The North and South Balconies and Garage Roof areas were generally observed to be in good condition. An overall view of the North and South Balconies and Garage Roof areas can be seen in *Figure B-1* and *Figure B-2*.
2. Localized areas of hairline cracking were observed at several of the kneewall joints. Refer to *Figure B-3* and *Figure B-4*.
3. Membrane separation cracking was observed over the garage roof area adjacent to unit 107 balcony. Refer to *Figure B-5*.
4. A deck-to-wall joint was observed to exhibit signs of cracking, adhesion failure with stucco delamination at unit 107 balcony. Refer to *Figure B-6*.

The surveyed balcony structures and garage roof areas were observed to generally be in good condition. BillerReinhart recommends the board have the cracking and spalling observed at the kneewalls and waterproofing coatings be repaired as soon as possible to prevent potential moisture intrusion from occurring. BillerReinhart recommends that the balcony and garage roof areas waterproofing membrane continue to be monitored and reevaluated in the next 4-5 years.

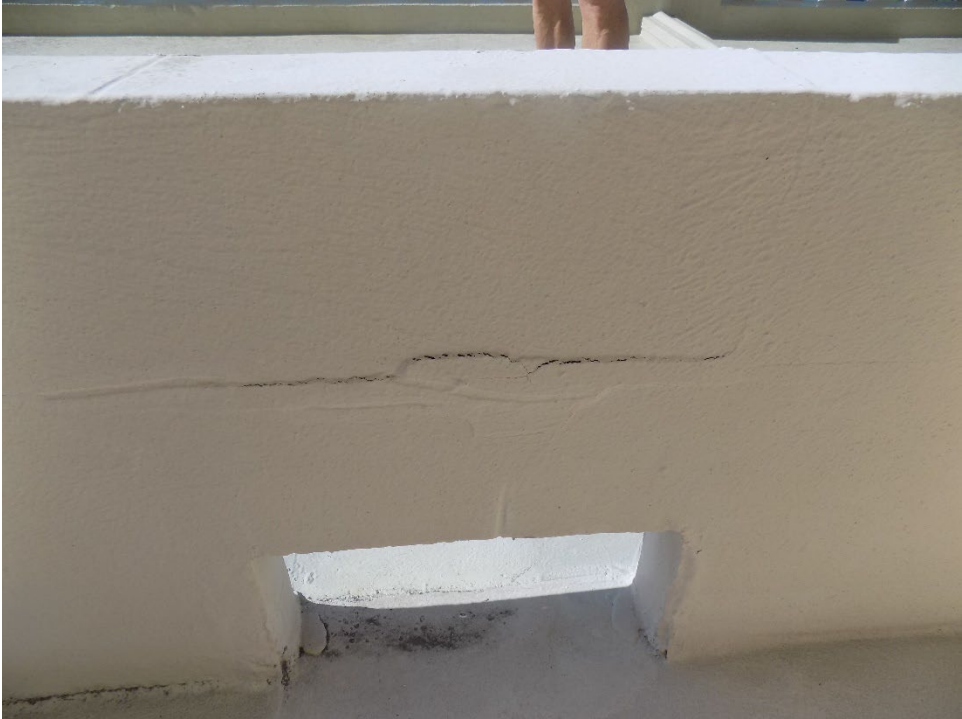
Figure B-7

5. Multiple areas of spalling were detected on the kneewalls. Refer to *Figure B-7* through *Figure B-9*.
6. Isolated areas of stucco delamination were detected on the accessible balcony exterior wall surfaces. Refer to *Figure B-10* through *Figure B-13*.

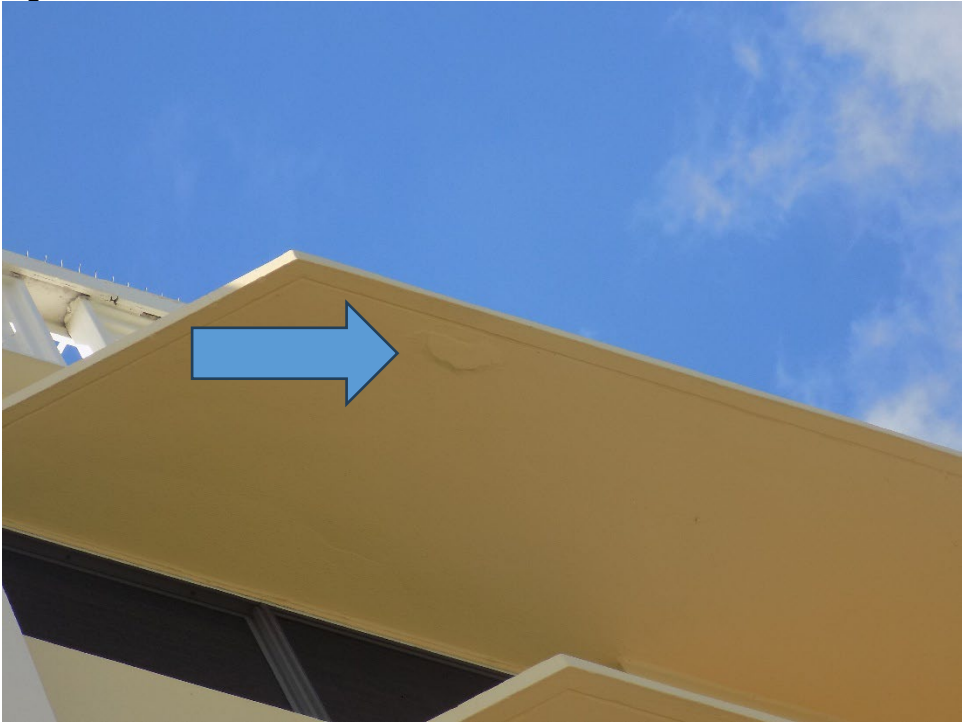
Figure B-17

1. Several areas on the cantilevered eyebrows were observed to exhibit signs consistent with concrete spalling. Refer to *Figure B-17* through *Figure B-20*.

The cantilevered eyebrows were generally observed to be in fair condition with several small areas of spalling being observed. BillerReinhart recommends a restoration project be undertaken for the repair and maintenance of the cantilevered eyebrows. BillerReinhart recommends the restoration project be undertaken during the same time as the exterior wall project described above.
