Harbour Club Condominium No. Three, Inc.

October 31, 2023 • Belleair Bluffs, FL

**STRUCTURAL INTEGRITY
RESERVE STUDY**

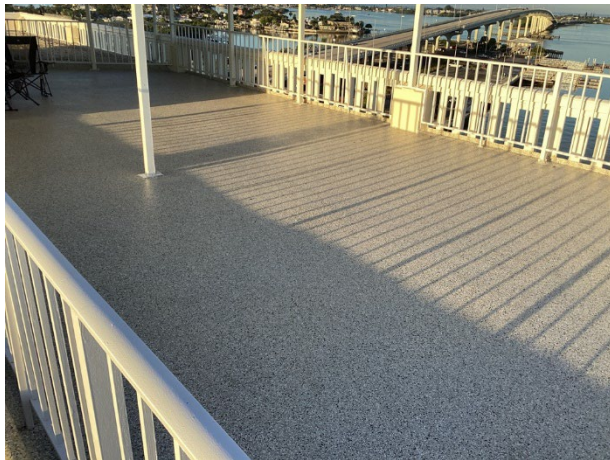
Condition: Good to fair overall with minor previous repairs and coating deterioration evident. We note the following:

- Sealants are in good to fair condition
- The coatings are in good to fair condition
- Isolated concrete coating deterioration is evident
- Exposed reinforcements were not observed at the time of our inspection

Rooftop balcony overview

Useful Life: Capital repairs including a close-up visual inspection, patching of delaminated concrete, routing and filling of cracked concrete, and waterproof coating applications every 8- to 12-years.

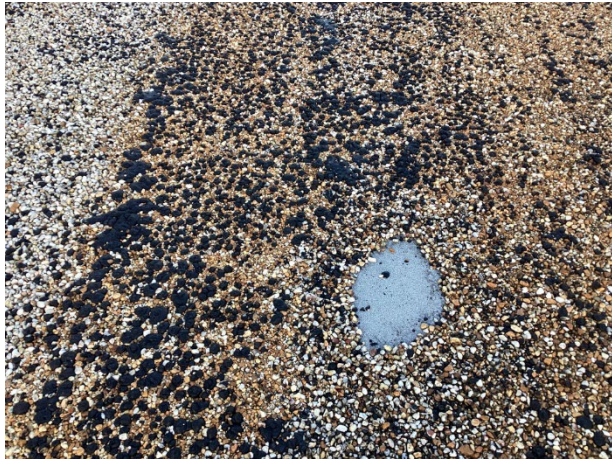
Ballast displacement and encapsulation at the upper roof

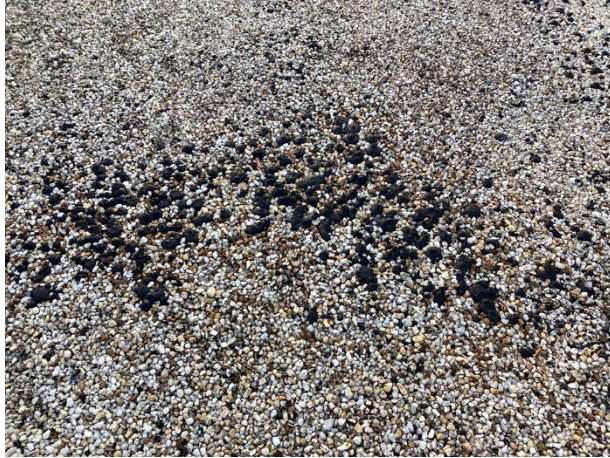
Ballast encapsulation at the upper roof

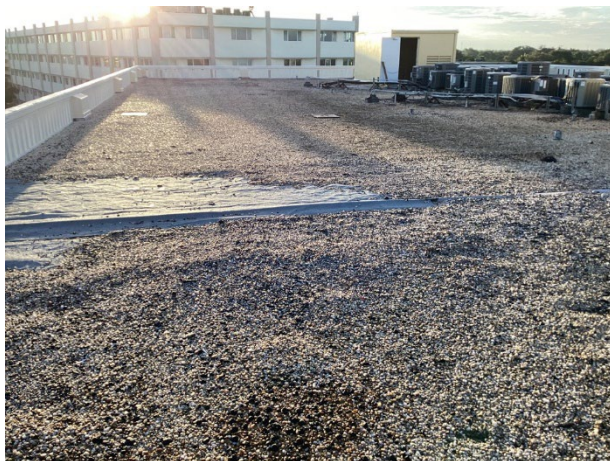
Ballast displacement and ridging at the upper roof

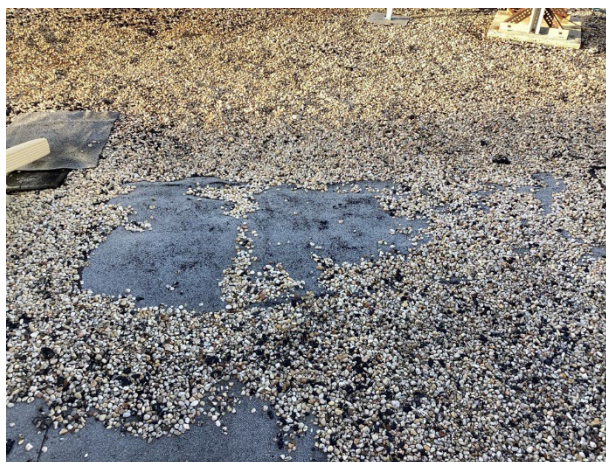
Ballast displacement at the upper roof

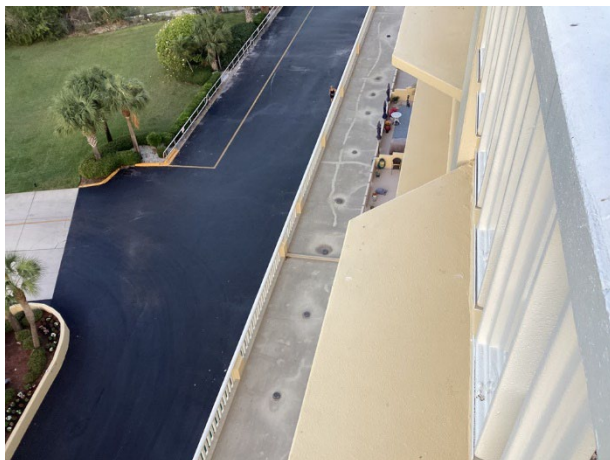
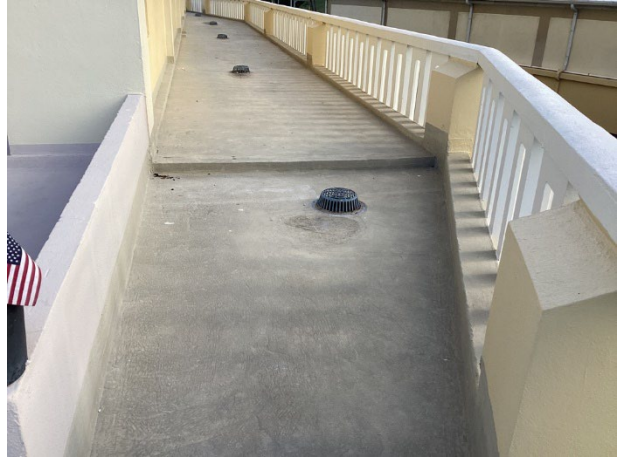
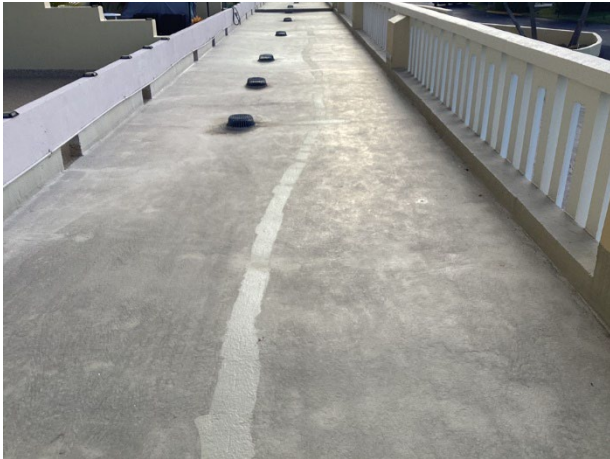
Condition: Good to fair overall with isolated previous repairs evident. Management and the Board do not report history of leaks. We note the following:

- Minor previous membrane repairs are evident
- Sealant failure was not reported at the time of our inspection

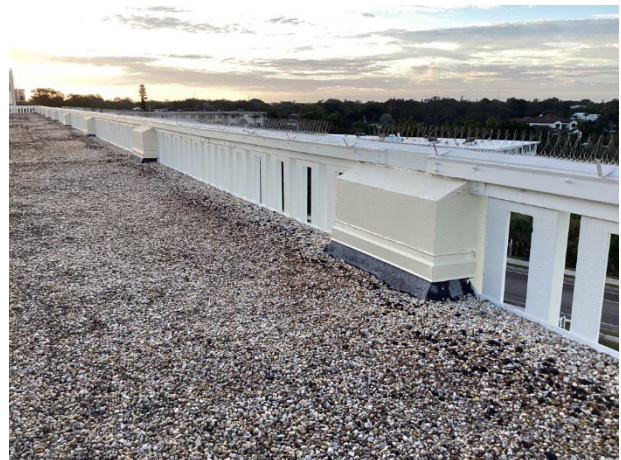
Concrete safety railings at the roof

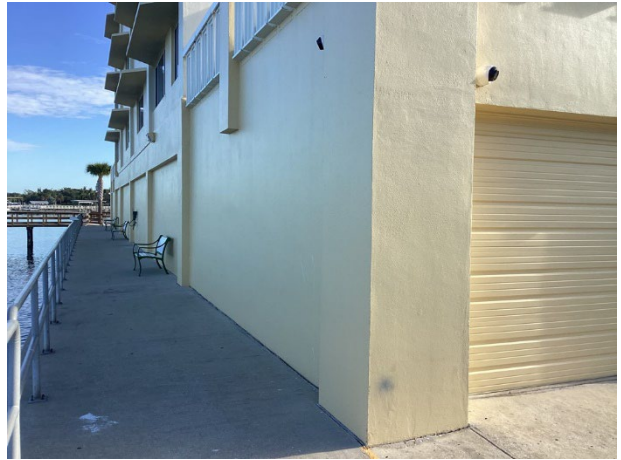
Stucco wall finishes

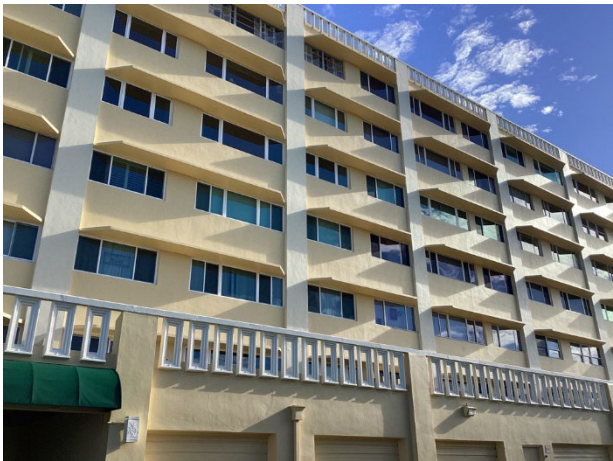
Stucco wall finishes and concrete railing finishes

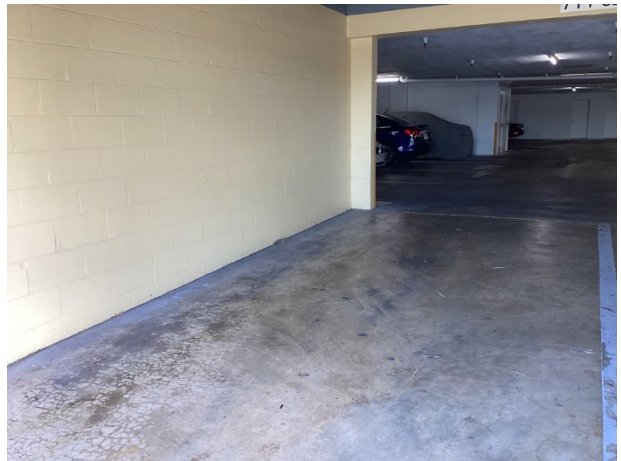
Paint finishes at the garage

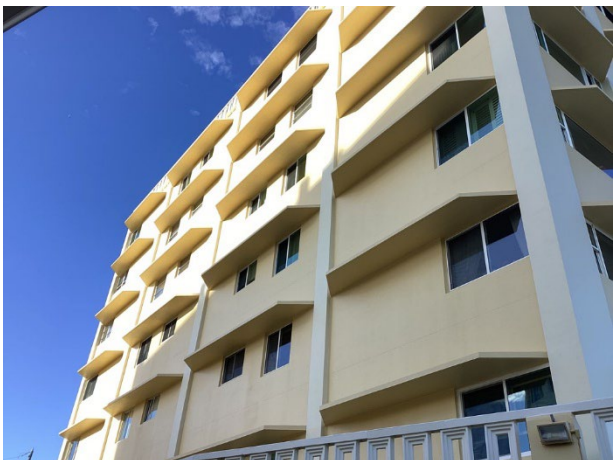
Stucco wall finishes

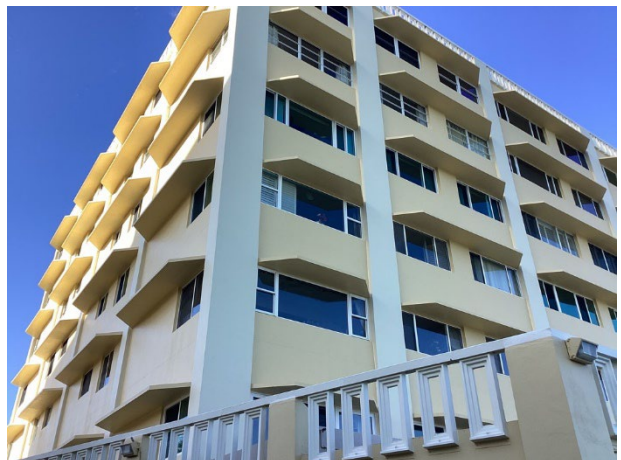
Stucco wall finishes

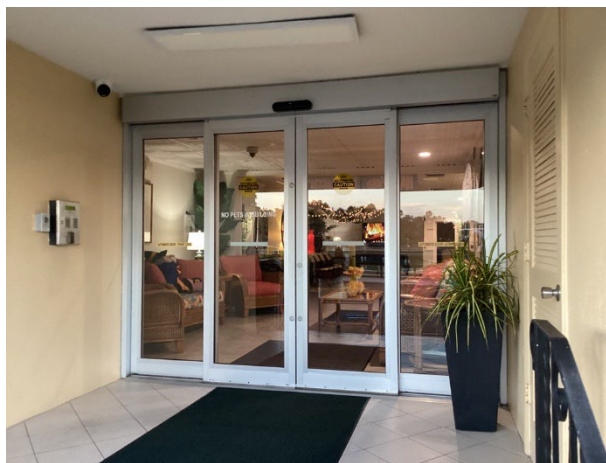
Condition: Good overall with no significant deterioration evident. We note the following:

Common windows and doors at the main lobby entrance

Expenditure Detail Notes: Expenditure timing and costs are depicted in the **Reserve Expenditures** table in Section 3. Based on the Association's proximity to the coast, we recommend replacement with impact grade windows and doors.

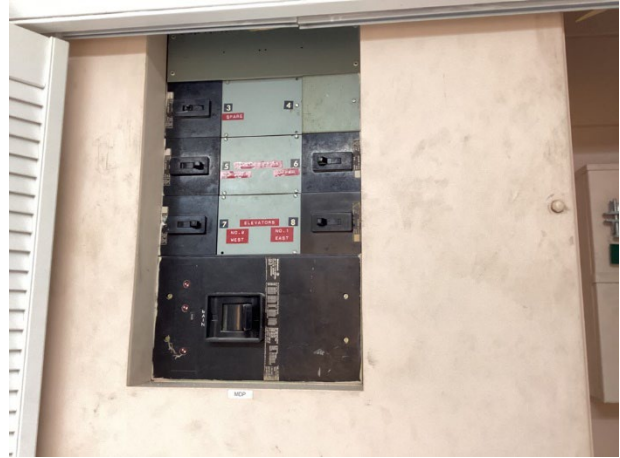
- We observed potentially combustible materials stored near the electrical panels. Per 10.18.5 of NFPA 1, "Combustible material shall not be stored in boiler rooms, mechanical rooms, or electrical equipment rooms.". The Association should further investigate and remove materials, if necessary.
- Some electrical panel locations were not labeled. The Association should consider adding clear and proper signage to the electrical panel locations.
- No obvious exposed wires were observed during our site inspection. However, our inspection is not exhaustive and the Association should conduct periodic inspections of the electrical rooms to ensure no unsafe conditions develop.
- Rust was not present at electrical panels. Continual monitoring of the panels is prudent to ensure excessive moisture is not present at them.
- No apparent water was observed in or near the electrical rooms.

Electrical system components

We recommend the Association conduct thermoscans of the distribution panels and circuit protection panels, and inspections of the transformers for any indications of arcing, burning or overheating on a regular basis, funded through the operating budget. Verification of the integrity of all connection points minimizes the potential for arcing and fires.

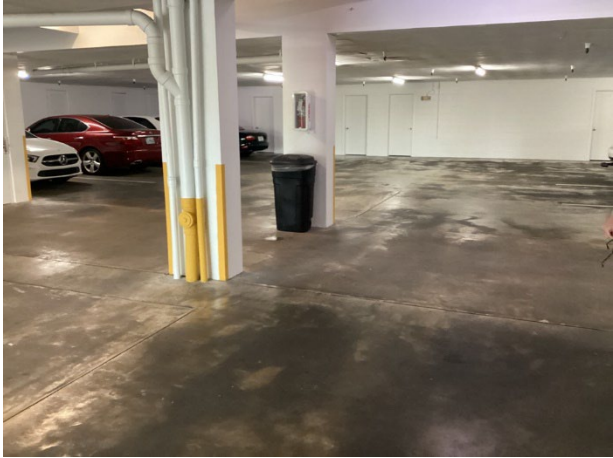
- We note isolated areas of cracks
- No significant spall was observed
- No areas of exposed reinforcing steel were observed
- The overall condition of the floor drains is satisfactory
- No areas of ponding water or evidence of poor drainage was observed
- No areas of vehicular damage were observed at the columns

On-grade garage floor overview

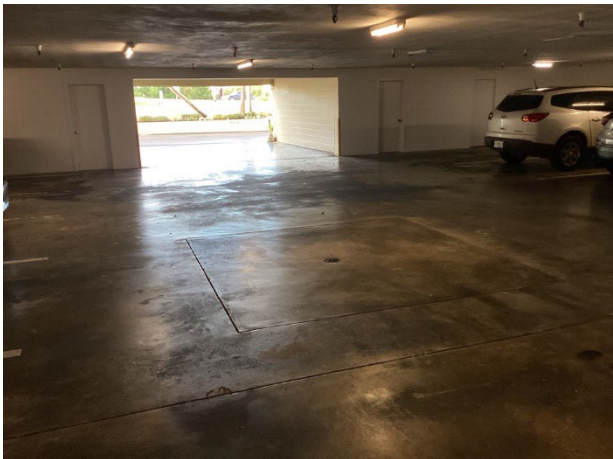
On-grade garage floor overview

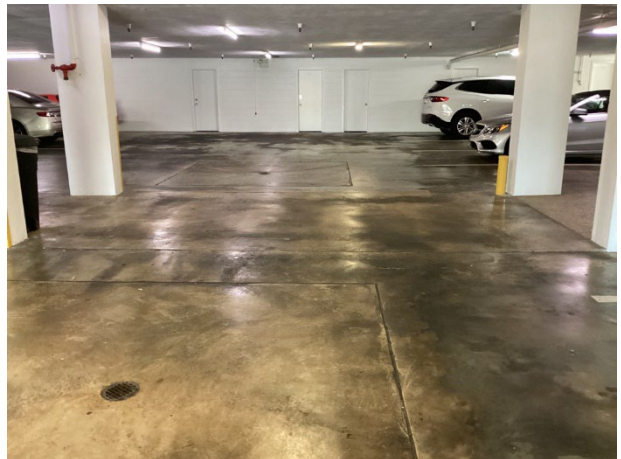
On-grade garage floor overview

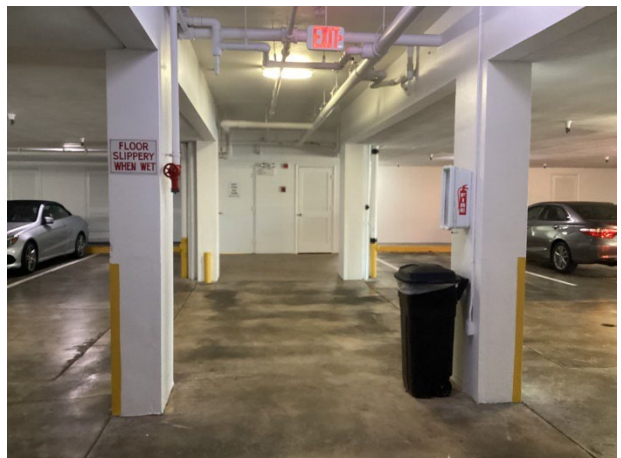
On-grade garage columns overview

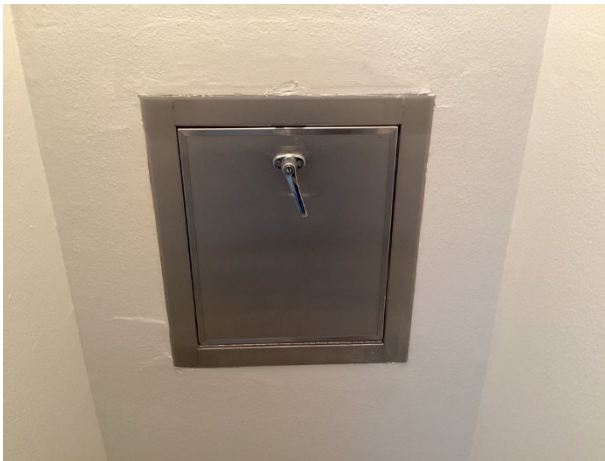
History: The trash chute is original and the doors have been replaced as-needed.

Condition: Reported satisfactory without operational deficiencies

Trash chute door

Component Detail Notes: Damaged doors or poor door operation will result in a decreased useful life. The Association should fund interim repairs and partial replacements of the doors through the operating budget.
