MILESTONE PHASE 1 CONDITION SURVEY REPORT

Harbour Club Condominium No. Three

100 Bluff View Dr., Belleair Bluffs, FL 33770

**Subject: Milestone Phase 1 Structural Condition Survey Report
Harbour Club Condominium No. Three
100 Bluff View Dr.
Belleair Bluffs, FL 33770**

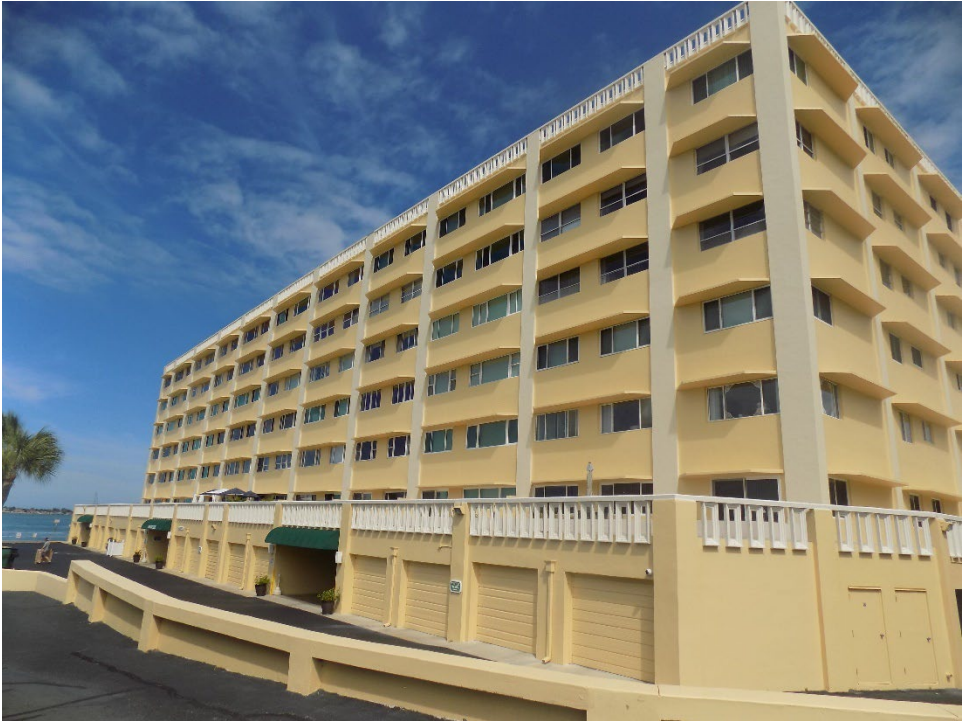
Figure A-1

1. South elevation, North elevation, West elevation, and East elevation exterior wall areas are shown in *Figure A-1* through *Figure A-4*, respectively.
2. Multiple areas of stucco delamination were detected throughout the accessible ground level exterior walls. Refer to *Figure A-5* through *Figure A-7*.
3. Isolated areas of blistering paint with entrapped moisture were detected on the exterior walls. Refer to *Figure A-8*.
4. Isolated areas of corrosion staining were detected on the precast rail surfaces. Refer to *Figure A-9*.

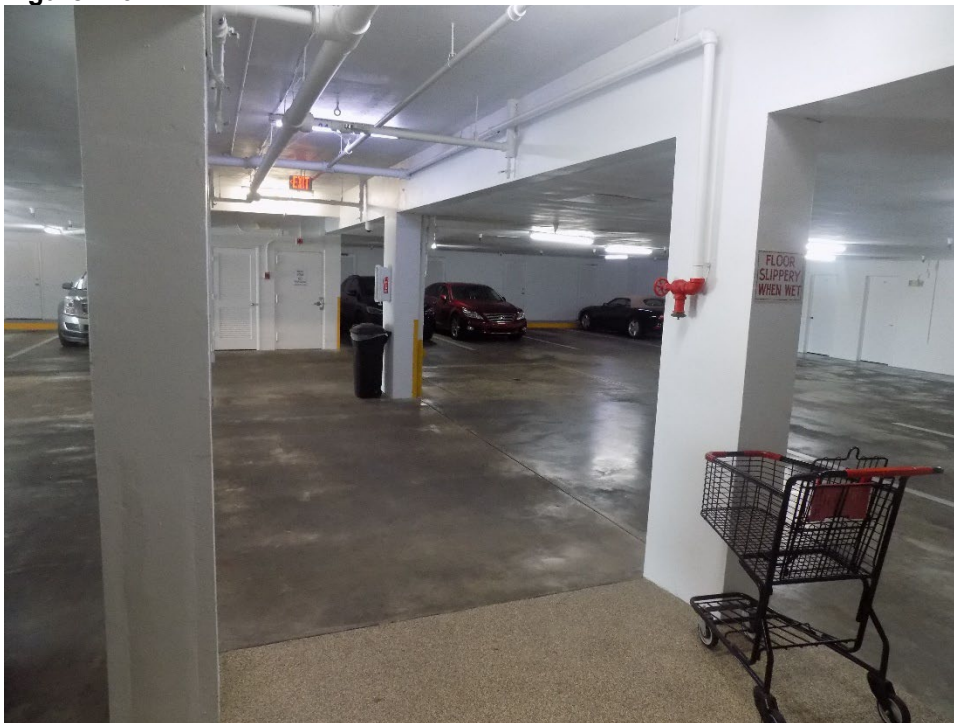
Figure A-10

1. An overall view of a typical parking garage area can be seen in *Figure A-10* and *Figure A-11*.
2. Localized areas of concrete spalling and/or delamination were detected on the parking garage columns. Refer to *Figure A-12* through *Figure A-14*.
3. Isolated areas of concrete spalling with exposed corroded reinforcement were observed on one of the parking garage overhead beams. Refer to *Figure A-15*.

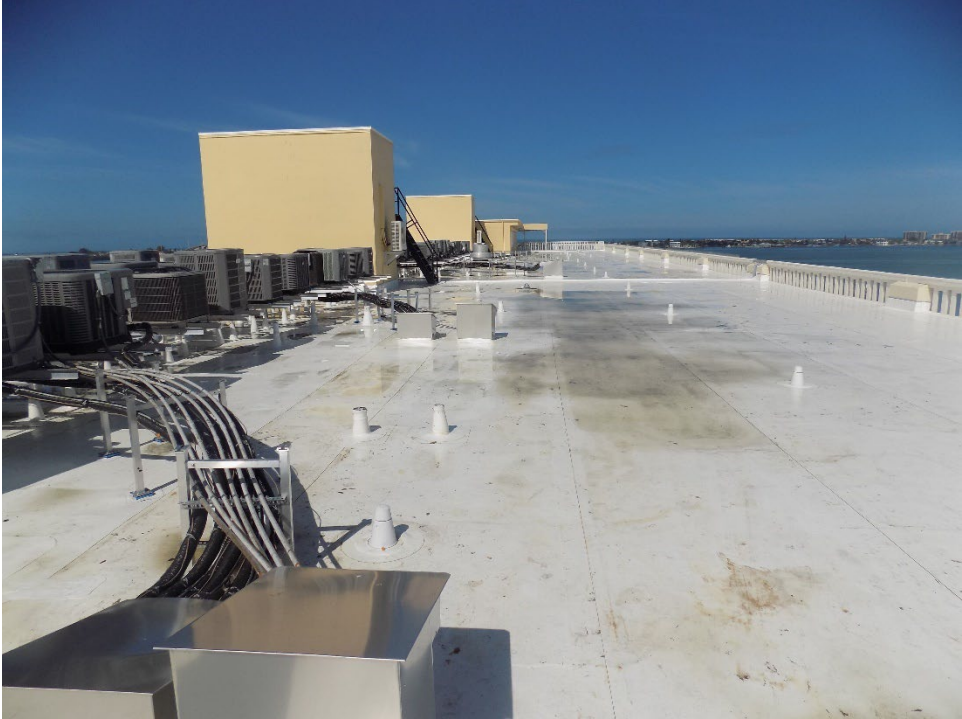
Figure A-23

1. The roof was generally observed to be in good condition. An overall view of the roof can be seen in *Figure A-23* through *Figure A-24*.
2. Localized areas of delaminated stucco and spalling were detected on the walls of the rooftop structures. Refer to *Figure A-25* through *Figure A-26*.
3. Multiple areas of ponding with staining were observed throughout the main roof area. Refer to *Figure A-27*.
4. The west elevator stair landing was observed to exhibit signs of corrosion with section loss at the wall to landing angle support connection and top tread plate. Refer to *Figure A-28* and *Figure A-29*.

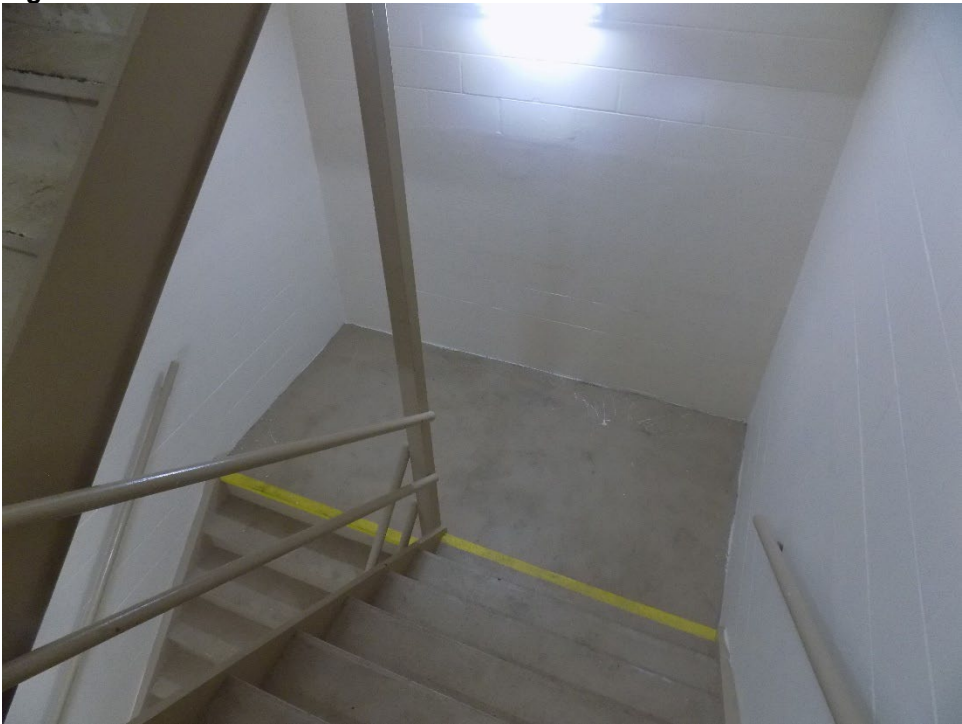
Figure A-30

1. The staircases was generally observed to be in good condition. An overall typical view of the staircase can be seen in *Figure A-30*.

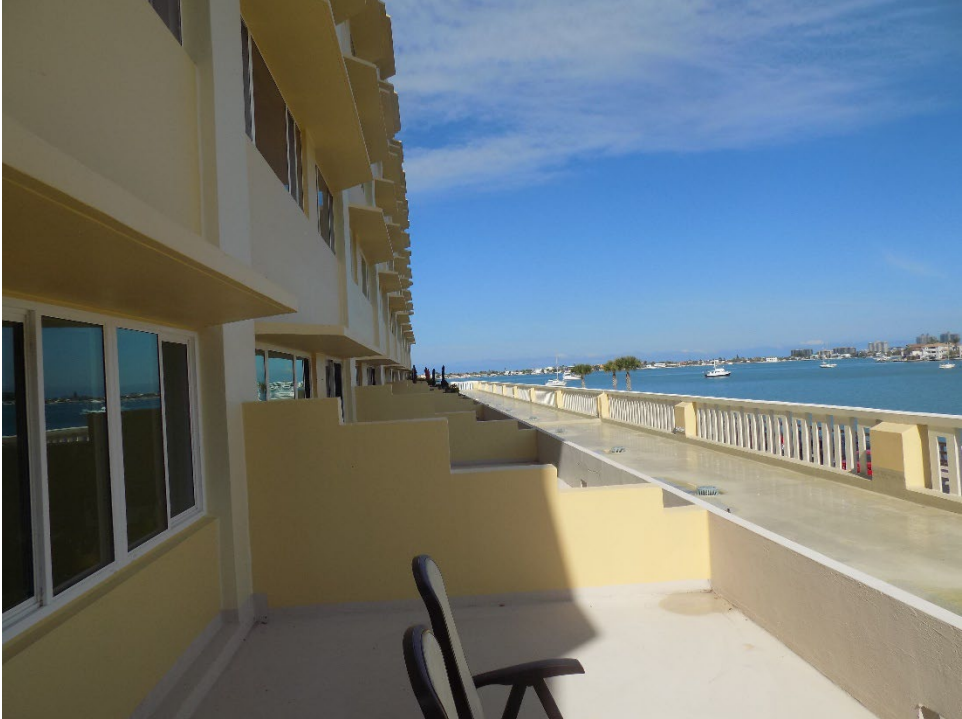
Figure B-1

1. The North and South Balconies and Garage Roof areas were generally observed to be in good condition. An overall view of the North and South Balconies and Garage Roof areas can be seen in *Figure B-1* and *Figure B-2*.
2. Localized areas of hairline cracking were observed at several of the kneewall joints. Refer to *Figure B-3* and *Figure B-4*.
3. Membrane separation cracking was observed over the garage roof area adjacent to unit 107 balcony. Refer to *Figure B-5*.
4. A deck-to-wall joint was observed to exhibit signs of cracking, adhesion failure with stucco delamination at unit 107 balcony. Refer to *Figure B-6*.
