Harbour Club Condominium No. Three, Inc.

October 31, 2023 • Belleair Bluffs, FL

**STRUCTURAL INTEGRITY
RESERVE STUDY**

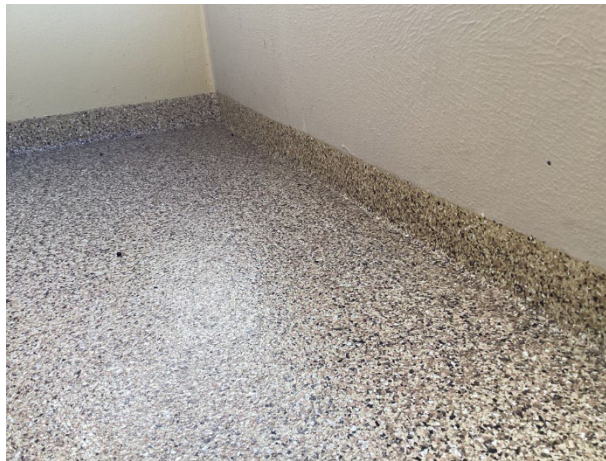
Balcony sealant overview

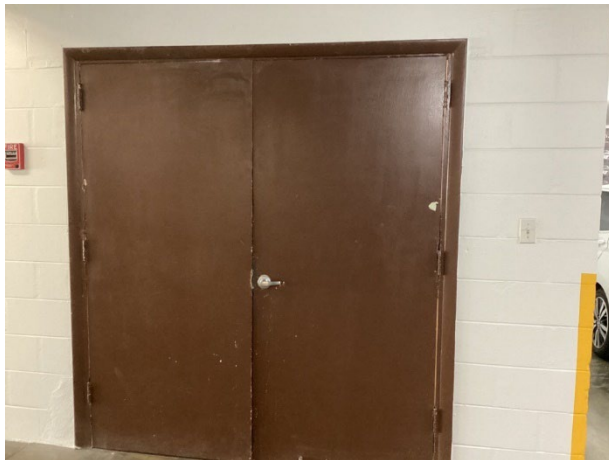
Condition: Good to fair overall with isolated rust evident.

Common doors

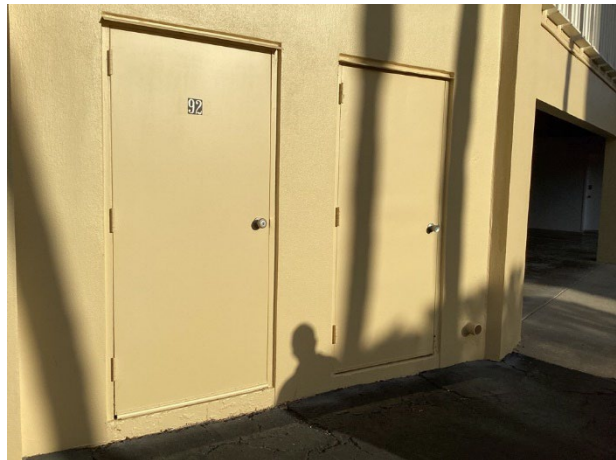
Common doors

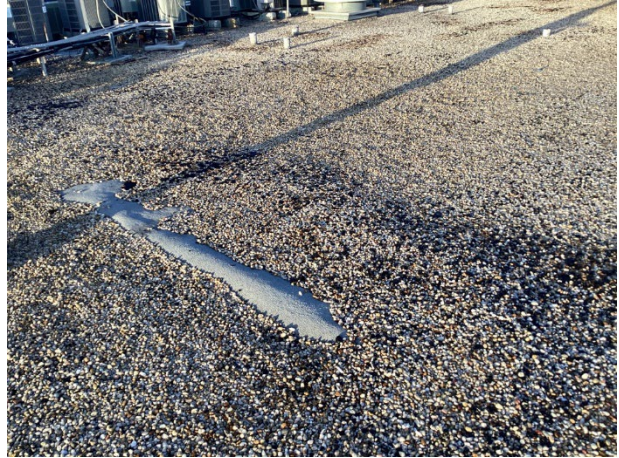
Ballast displacement and ridging at the upper roof

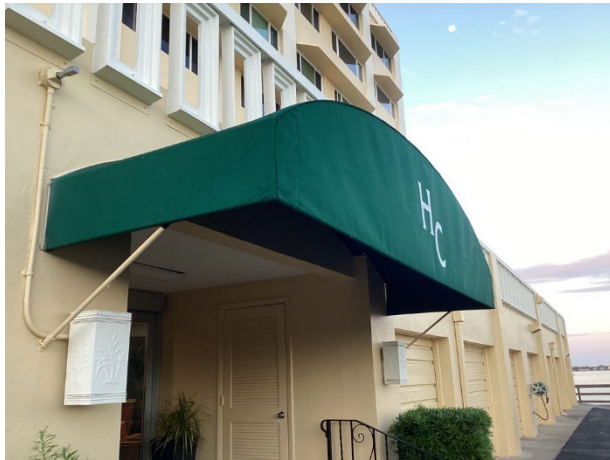
Condition: Good overall with no significant deterioration evident.

Awning

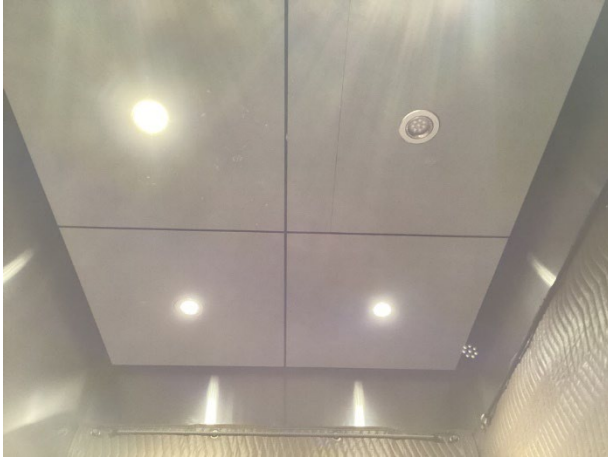
Condition: Good overall with no significant deterioration evident.

Elevator cab finishes

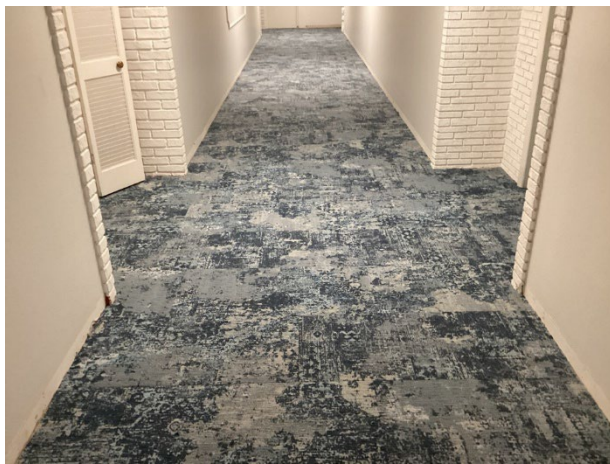
Condition: Good overall with no significant deterioration evident.

Carpet floor coverings

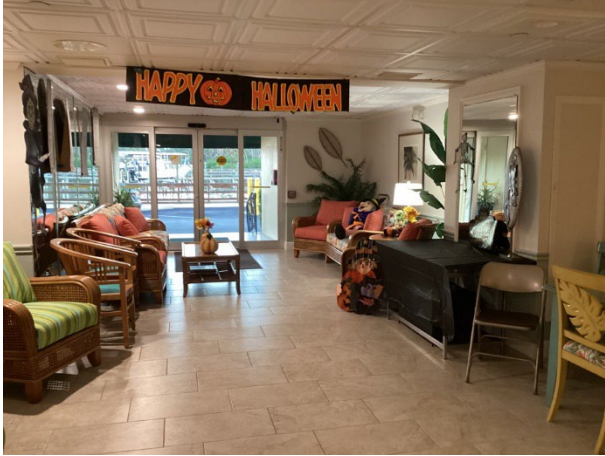
Condition: Good overall with no significant deterioration evident.

Lobby overview

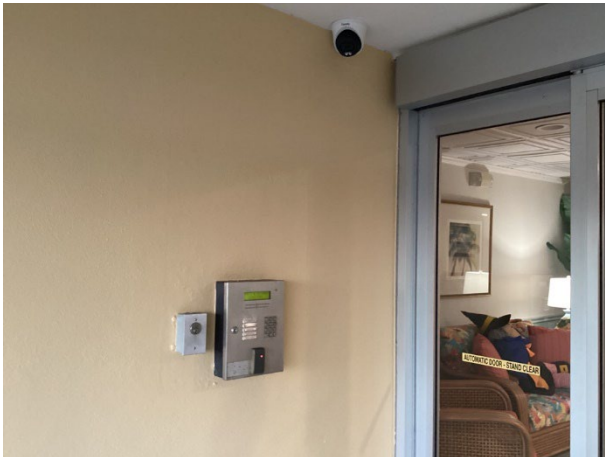
Security system components

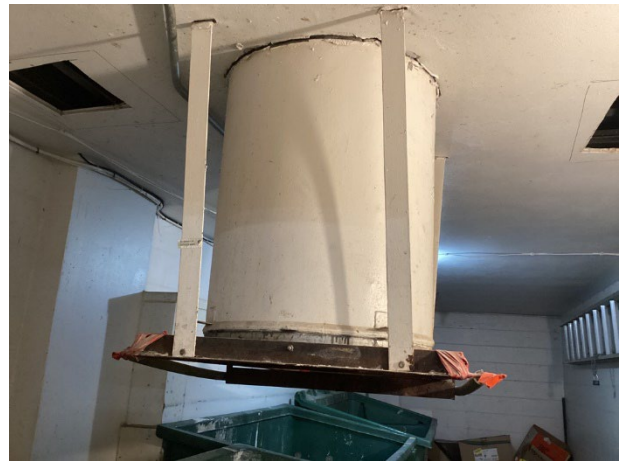
Trash chute

Preventative Maintenance Notes: We note the following select recommended preventative maintenance activities to maximize the remaining useful life:

- Weekly:
 - Clean doors and latches
 - In accordance with *NFPA 82* and fire code, ensure all trash chute doors self-latch and self-close
- Monthly:
 - Check operation of discharge door
 - Inspect fusible link and replace if necessary
 - If applicable, inspect, reinforce and/or replace discharge elbow
- Quarterly:
 - If applicable, check vent cap for damage and tighten fasteners
- Semi-annually:
 - Lubricate and/or replace doors, hinges and latches
 - Clear obstructions, clean and scrape trash chute and doors. The frequency of this activity may vary based upon occupancy and usage rates. This activity may also be based upon limitation of unwanted odors, prevention of harmful bacteria, pest infiltration and debris removal to further prevent fire hazards.
